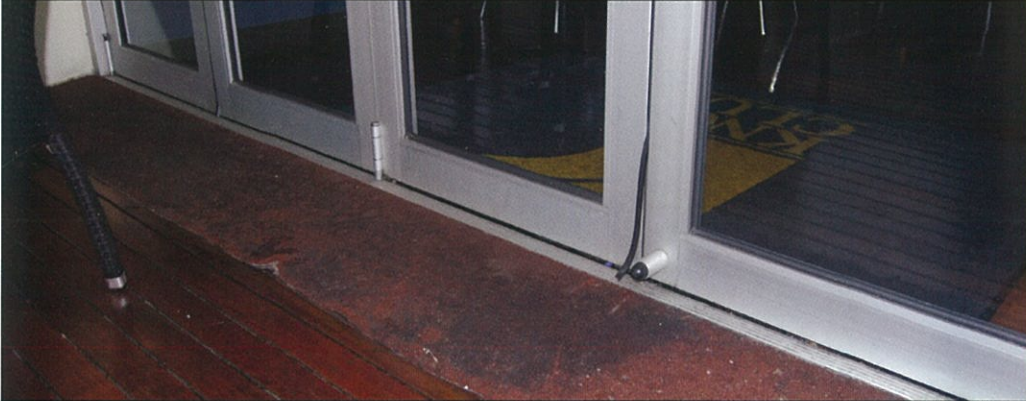
**BEFORE**

Wheelchair access ramp to outside deck area was worn and breaking down.

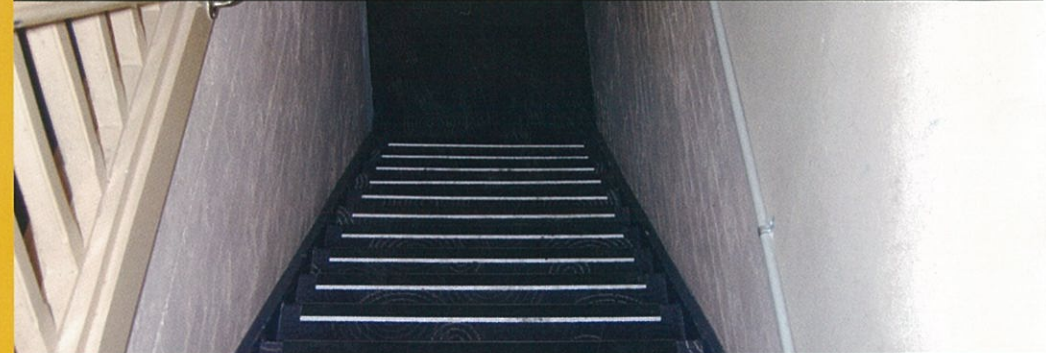
**BEFORE**

Poor lighting and visibility on carpeted stairway become a hazard in an emergency situation.

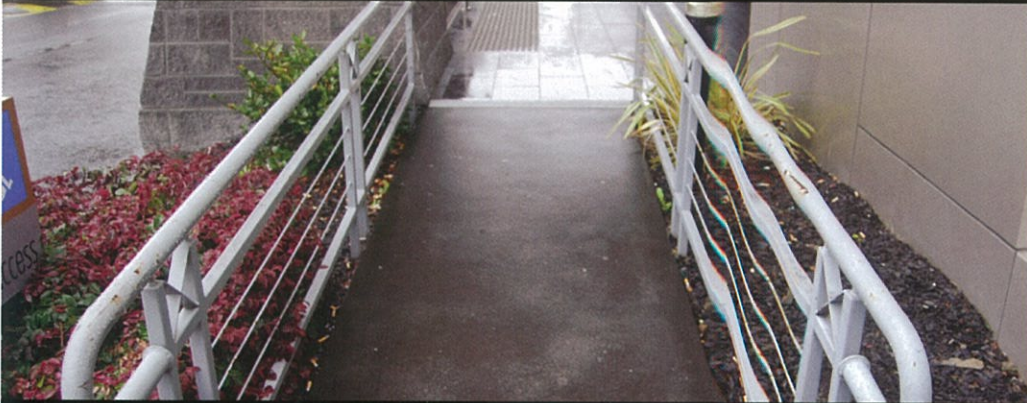
BEFORE

Where metal expansion plate joins tiled entrance to ramp, surface of plate becomes slippery when wet.

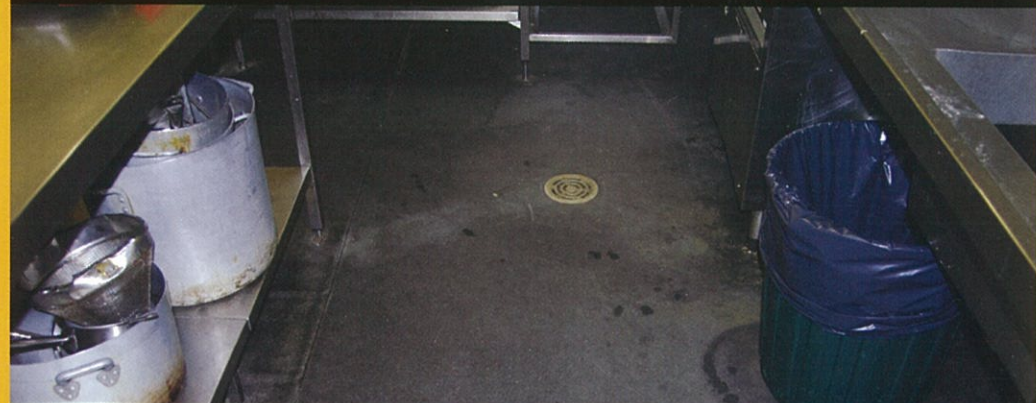
BEFORE

Staff were placed in a potential hazardous environment when the vinyl kitchen floor became contaminated with spillage, oil or water.
